*Circle Testing of Two Recreational
Off-Highway Vehicles on a Dirt Surface*

for:
Consumer Product Safety Commission

June 2013

**Vehicle Dynamics Division
7349 Worthington-Galena Rd.
Columbus, Ohio 43085**

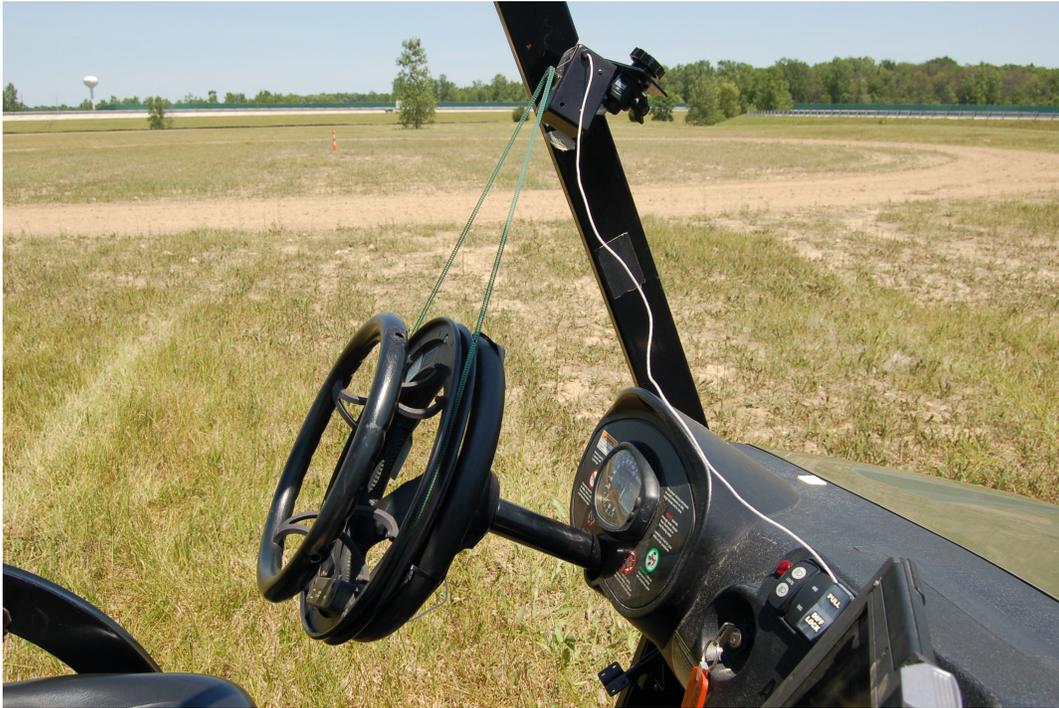
Figure 1: Steering Wheel Angle Sensor Mounted in Test Vehicle

No automated steering controller was required for this testing. A Sensor Developments, Inc., sensor was used to measure steering wheel angle for these tests. A photograph of this sensor mounted on one of the test vehicles is shown in Figure 2. A portion of the circular dirt test track can be seen in the background of Figure 2, and a more close-up view of the dirt surface is shown in Figure 3.

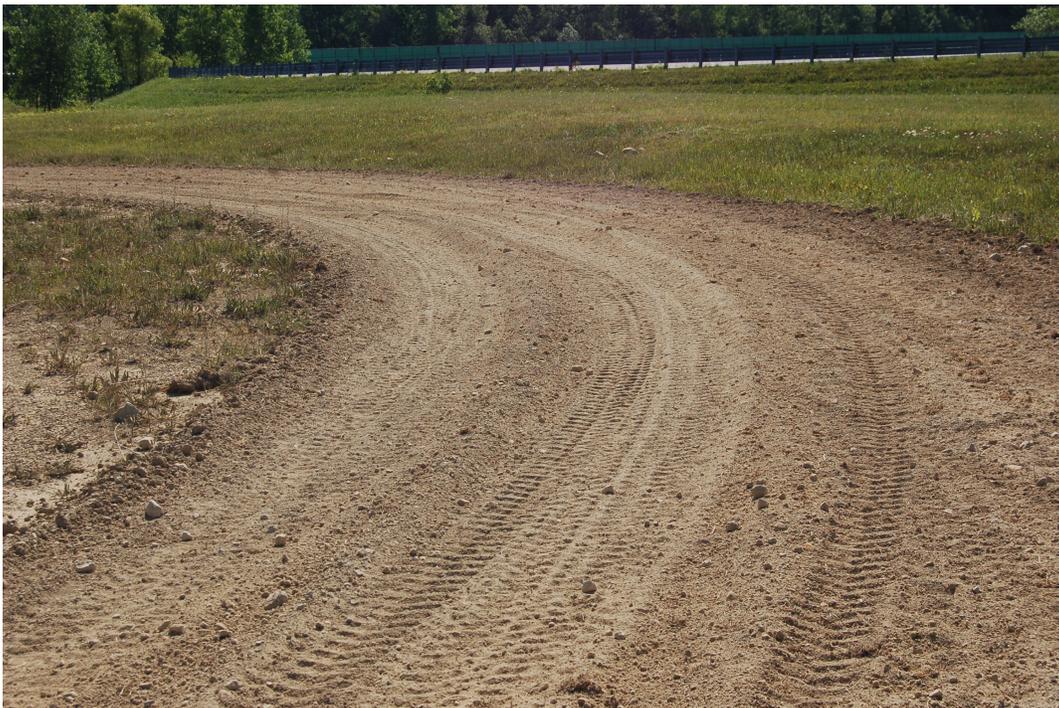
Figure 2: Prepared Dirt Surface after Several Tests were Completed

The surface used for testing was located at the Transportation Research Center, Inc. (TRC). TRC prepared the surface by cutting and removing any grass and topsoil necessary to produce a circular dirt track. The circular track had an inside radius of nominally 95 ft and an outside radius of nominally 115 ft (200 ft diameter, 20 ft wide circular dirt test track). Overall, the prepared circular track was smooth and flat.

For Vehicle F, Pages 1 through 6 of Appendix A contain results for the six sets of circle tests on dirt, and Pages 7 and 8 contains results for the two sets on asphalt. The data from the tests conducted on dirt are not as smooth or as repeatable as the data from the tests on the asphalt surface. The graphs indicate that the driver's steering inputs were more active (*i.e.*, requiring larger magnitude steering corrections) at all test speeds for the tests conducted on dirt than on asphalt. Lateral acceleration, roll angle, and yaw rate responses were also less smooth for the tests conducted on the dirt surface. As the circle tests on the dirt surface progressed, slight ruts and ridges formed along the wheel paths of travel. These ruts and ridges likely contributed to the less smooth vehicle responses and driver steering inputs.

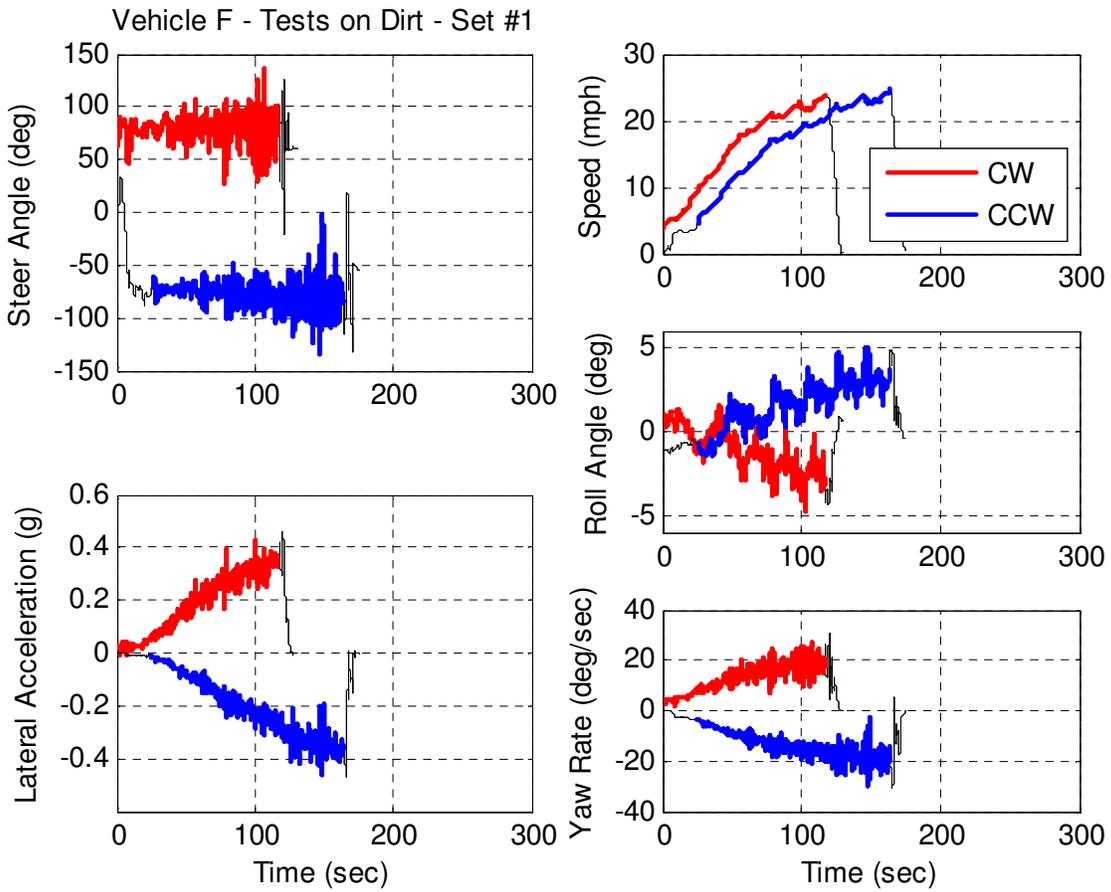
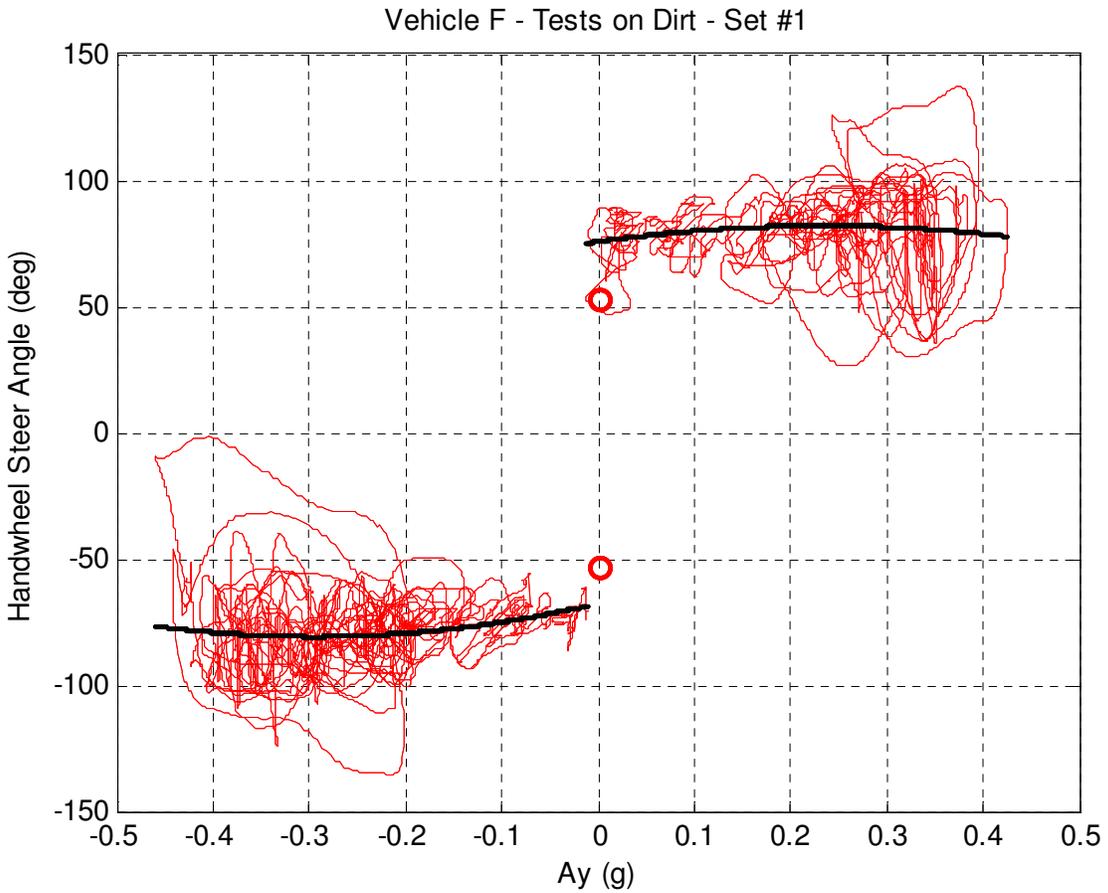
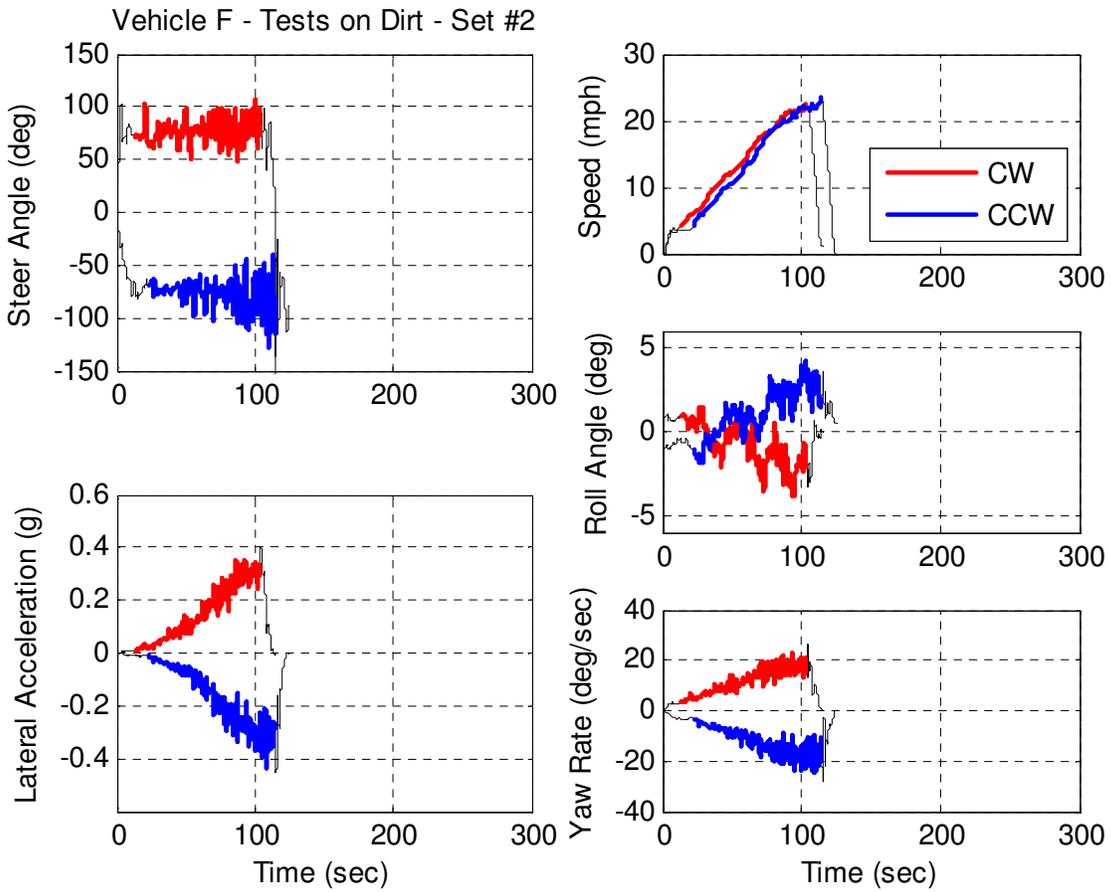
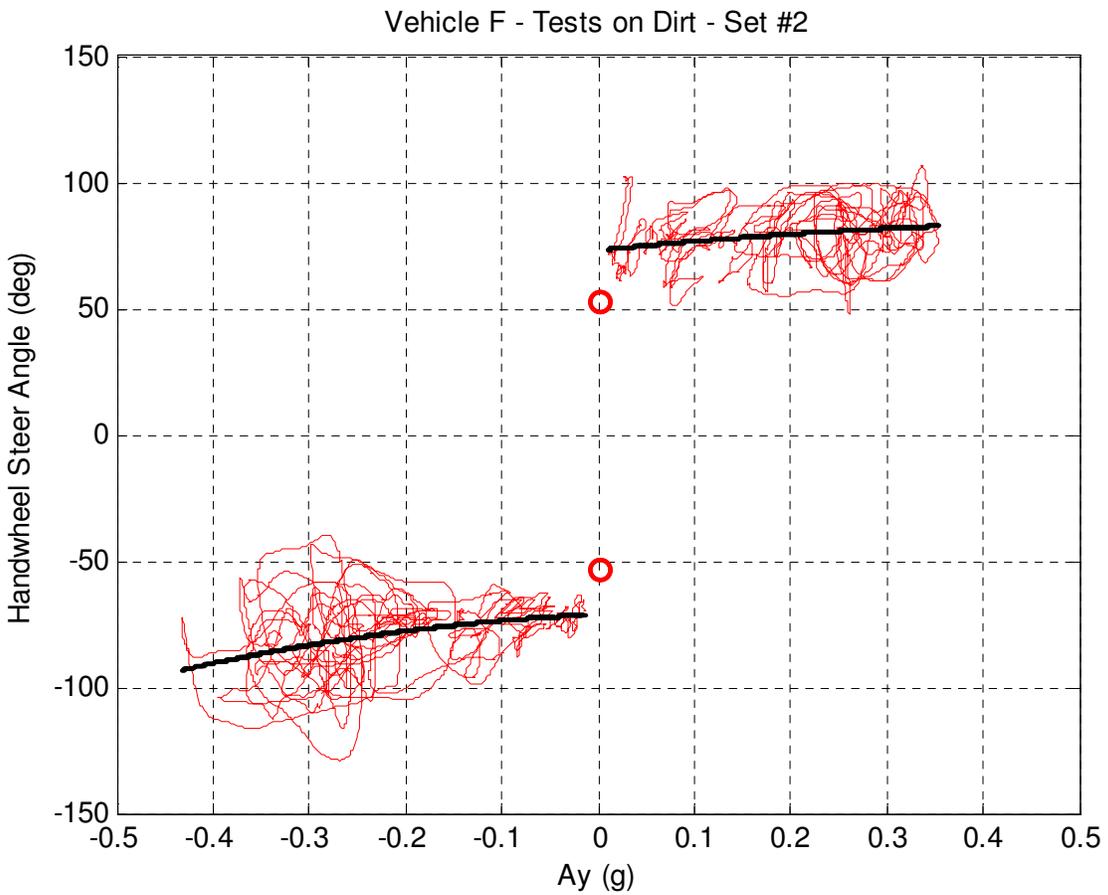
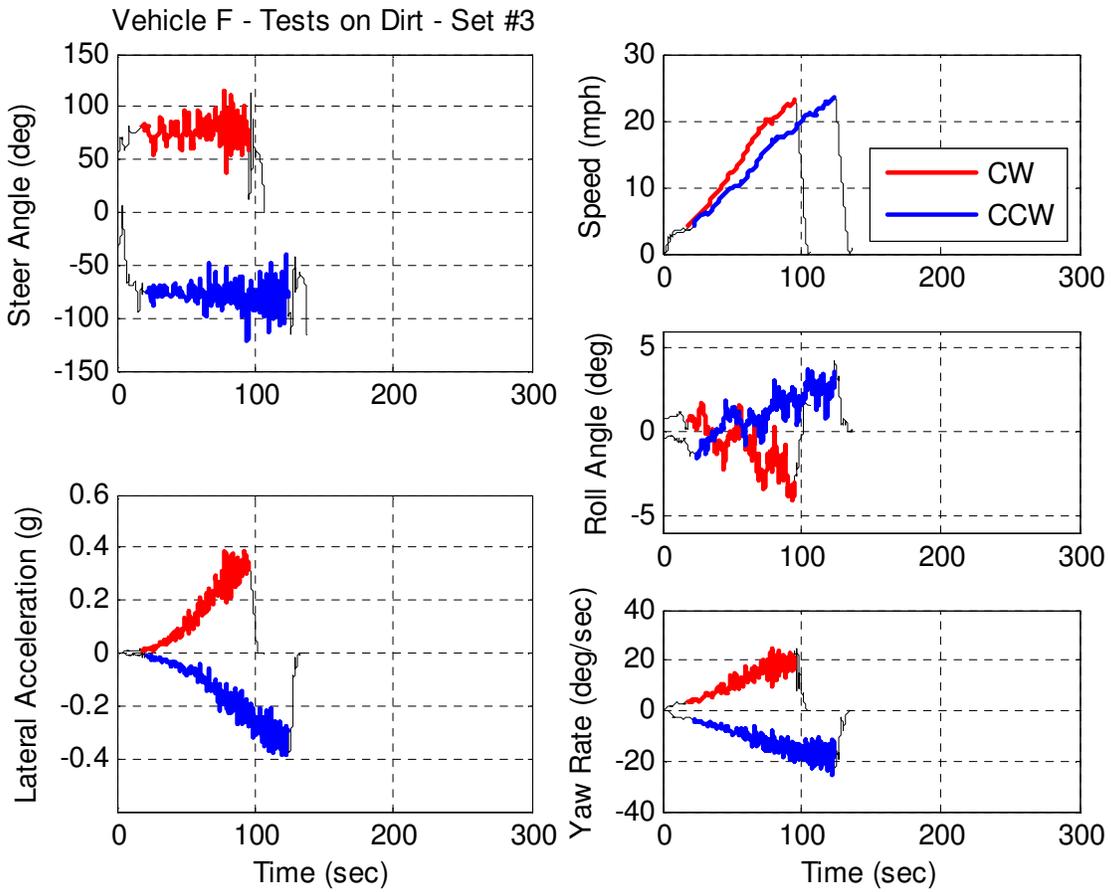
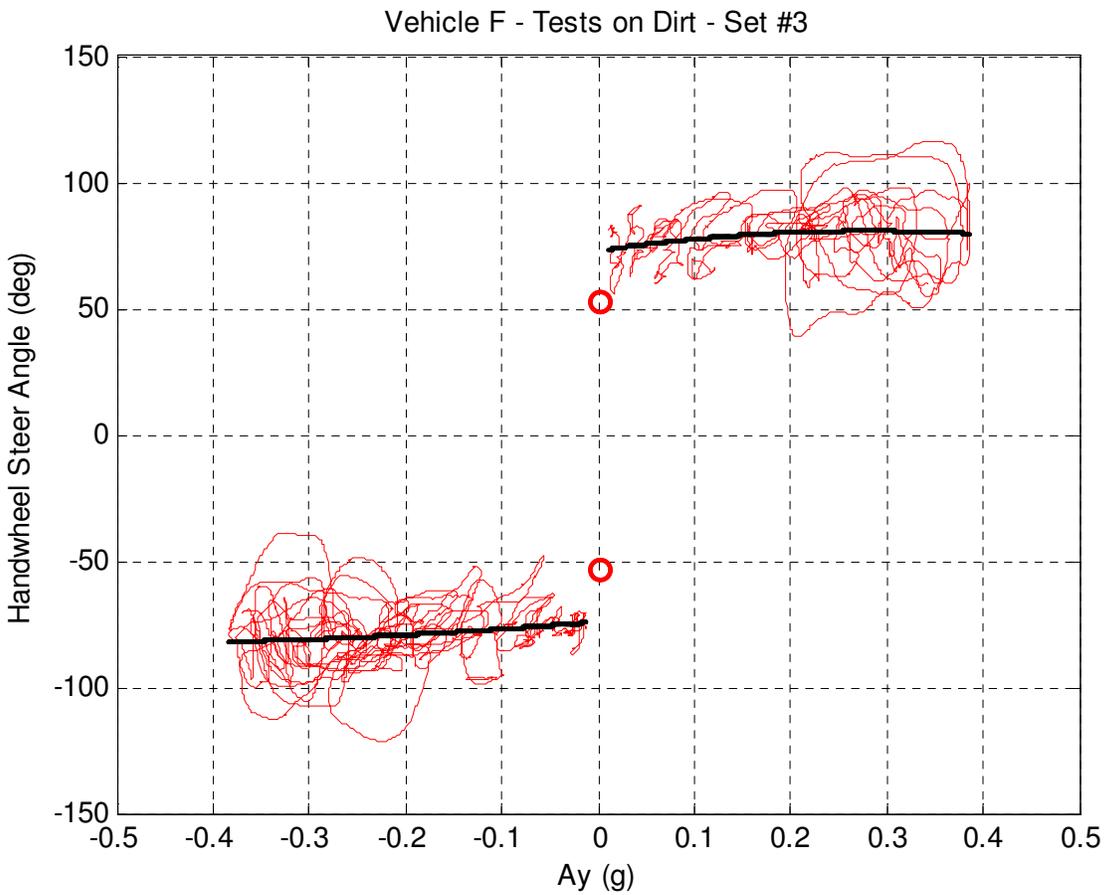
The first eight pages of Appendix A and the first five pages of Appendix B each contain test results from one set of circle tests, which each consists of one CW test and CCW test. The top half of these pages contain time domain plots of Steer Angle, Lateral Acceleration, Speed, Roll Angle, and Yaw Rate. All of the test data are sampled at 100 Hz. For the circle test results, the data shown were digitally low-pass filtered to 1.0 Hz, using a phaseless, eighth-order, Butterworth filter. The time domain data shown for each vehicle contain all of the data from the time the test driver started the data acquisition (prior to starting to move on the circle) to the time the test driver ended the data acquisition at the end of the test. The thin black lines for the CW and CCW tests show this full range of data. The thicker lines (red for CW and blue for CCW) indicate the range of data from the time the vehicle attained a speed of 4.0 mph, which is a lateral acceleration of 0.01 g on a 100 ft radius circle, until the maximum speed for each test was achieved (generally resulting in a maximum lateral acceleration of between 0.4 and 0.5 g.).

The bottom half of the pages show graphs of Handwheel Steer Angle versus A_y (lateral acceleration). The CW test results are in the upper right quadrants of the graphs, and the CCW test results are in the lower left quadrants of the graphs. The thin red lines show data in the range of vehicle speeds from 4.0 mph to maximum speed achieved during each test. For both the CW and CCW data, there are thicker lines indicating second-order polynomial curve fits to the data. The red circles on these graphs are the geometric Ackermann steer angles, a function of the steering ratio (K) times the wheelbase (L) divided by the circle radius (R), given by:

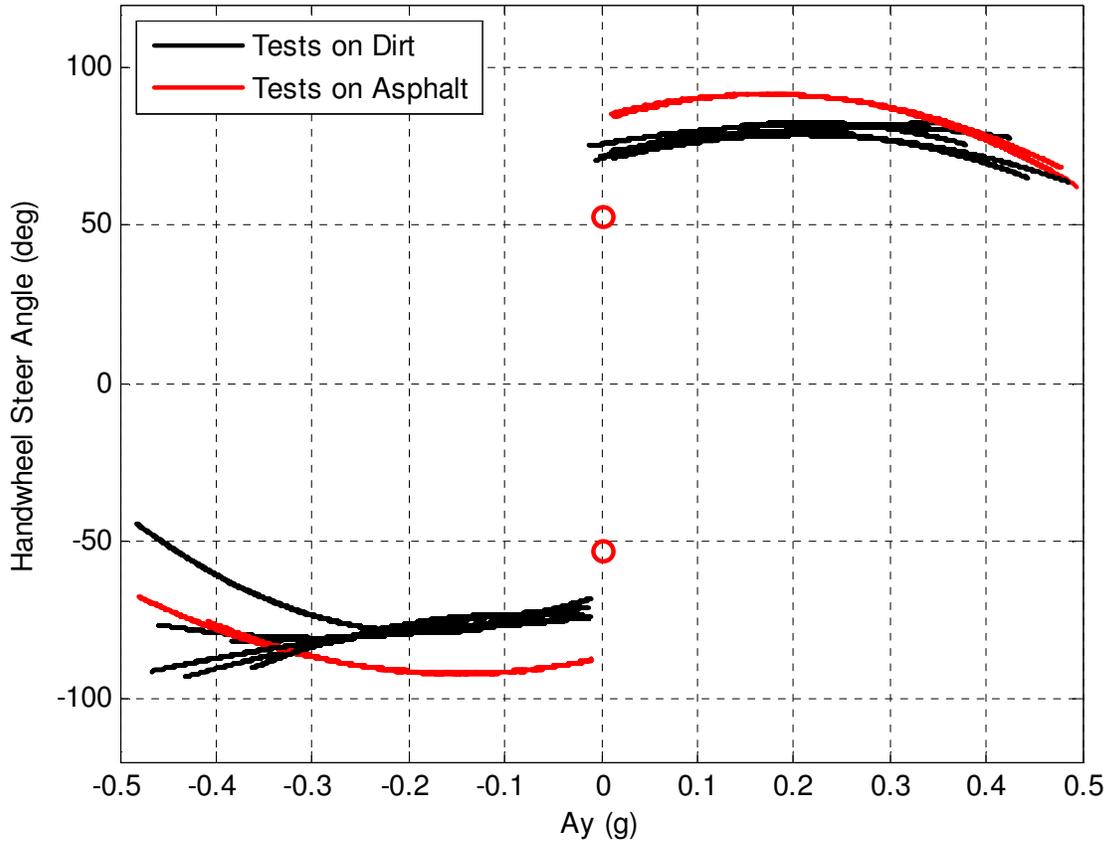
Vehicle F - Summary of All Tests

Page 9 of Appendix A shows summary curve fit results for all six sets of tests on dirt (black lines) and both sets of tests on asphalt (red lines) for Vehicle F. The results for the two tests on asphalt are very repeatable, and they are quite similar to the results obtained for Vehicle F from the previous 2011 testing with outriggers. This current testing indicates (as did the 2011 testing) that on asphalt, this vehicle exhibits a transition from understeer to oversteer at lateral acceleration levels below 0.2 g.

However, the six sets of tests conducted on dirt indicate varying results. Some of the curve fit trends indicate understeer characteristics and some of them indicate transition to oversteer, like the tests on asphalt did. The variations in the relatively large steering corrections for the tests conducted on dirt were the primary cause of the lack of repeatability in the trends of the understeer characteristic curves. Also, the steering magnitude required at low lateral acceleration levels is less on the dirt surface than it is on asphalt. This suggests that front tire tread interaction with the soil provides greater cornering (lateral) forces on the front axle in soil than on asphalt.

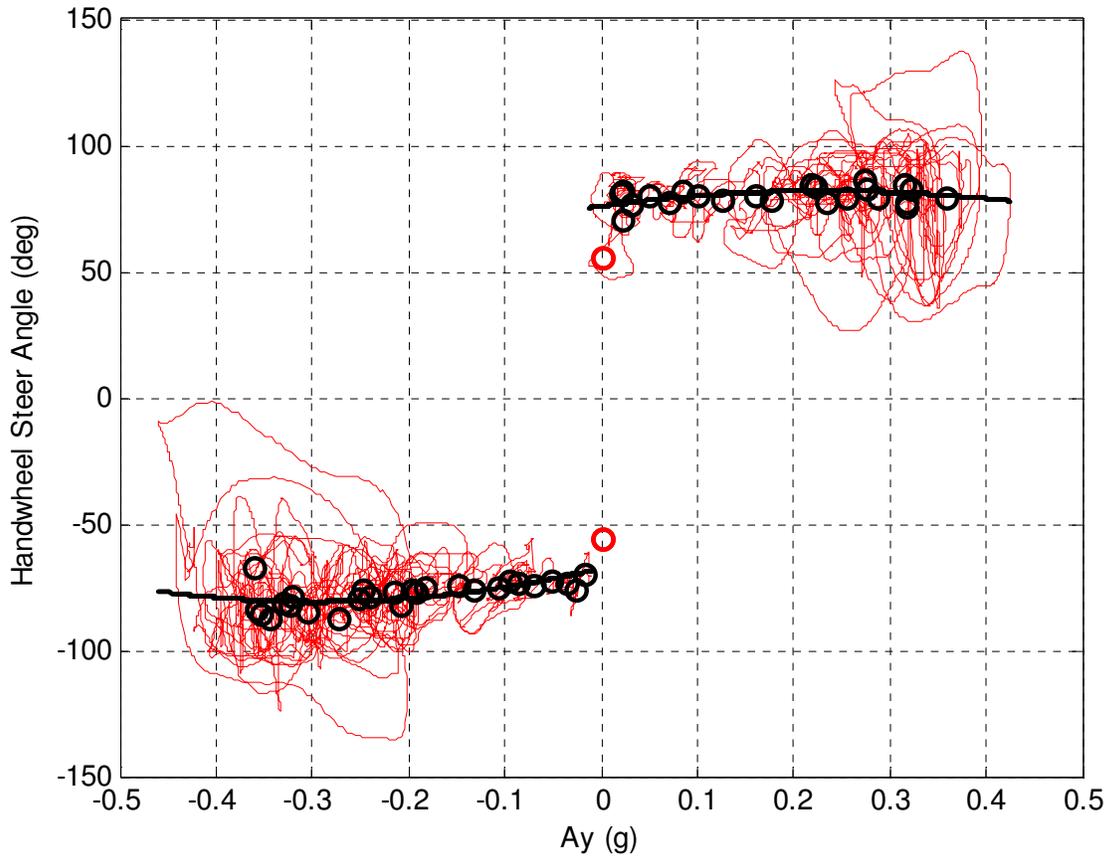
Vehicle F - Tests on Dirt - Set #1

Page 10 of Appendix A shows results from Set #1 tests on dirt and Set #1 tests on asphalt for Vehicle F. The red lines are the underlying data, the black lines are the second-order polynomial curve fits to the data, and the black circles are discrete points from averaging 0.5 second intervals (500 samples) of handwheel angle and lateral acceleration. Basically, this was done to see if using values averaged over some time range (instead of a curve fit) would provide a better (smoother) fit to the underlying data. The discrete points are generally scattered around the curve fit lines; but the scatter is greater for the tests on the dirt surface than for the tests on asphalt.

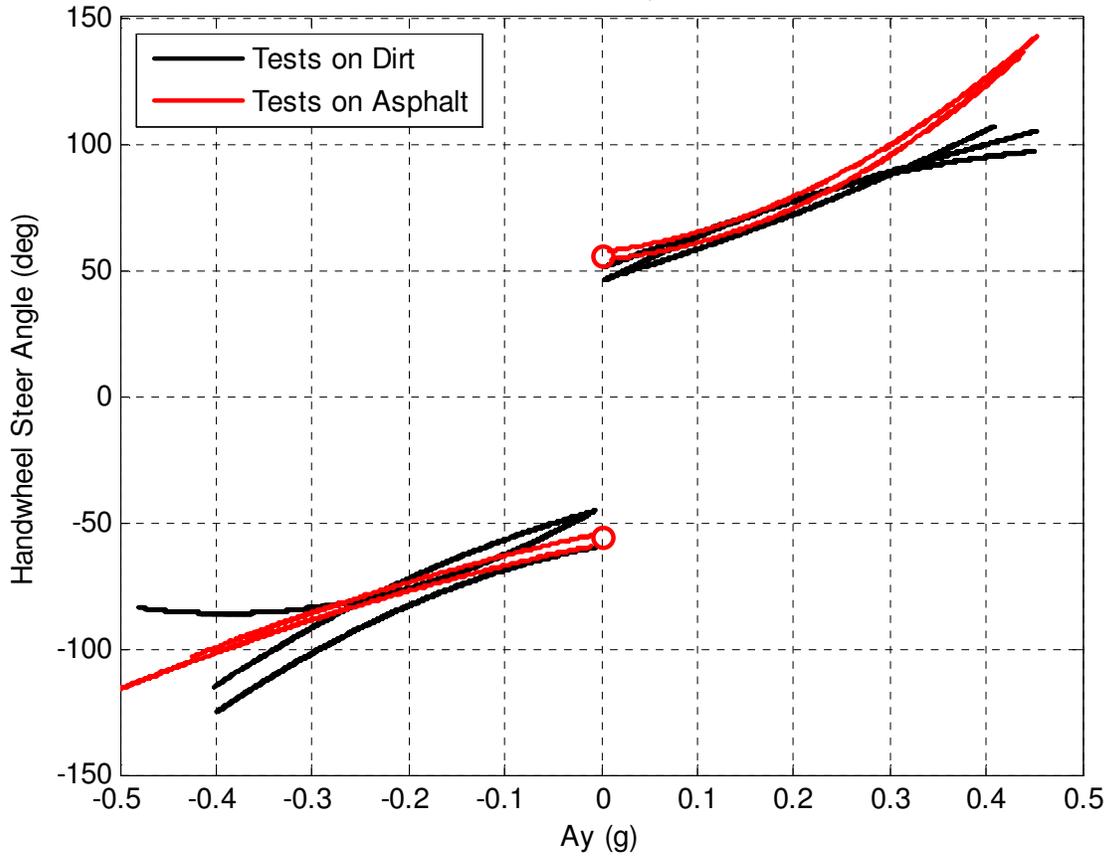
Vehicle G - Summary of All Tests

Page 6 of Appendix B shows summary curve fit results for all three sets of tests on dirt (black lines) and both sets of tests on asphalt (red lines) for Vehicle G. The results for the two tests on asphalt are very repeatable, and they are quite similar to the results obtained for Vehicle G from the previous 2011 testing with outriggers. This current testing indicates (as did the 2011 testing) that on asphalt, this vehicle exhibits understeer at all lateral acceleration levels.

However, the three sets of tests conducted on dirt indicate varying results. Some of the curve fit trends indicate transition to oversteer and some of them indicate understeer at all lateral levels, like the tests on asphalt did. For the tests conducted on dirt, the variations in the relatively large steering corrections were the primary cause for the lack of repeatability in the trends of the understeer characteristic curves.

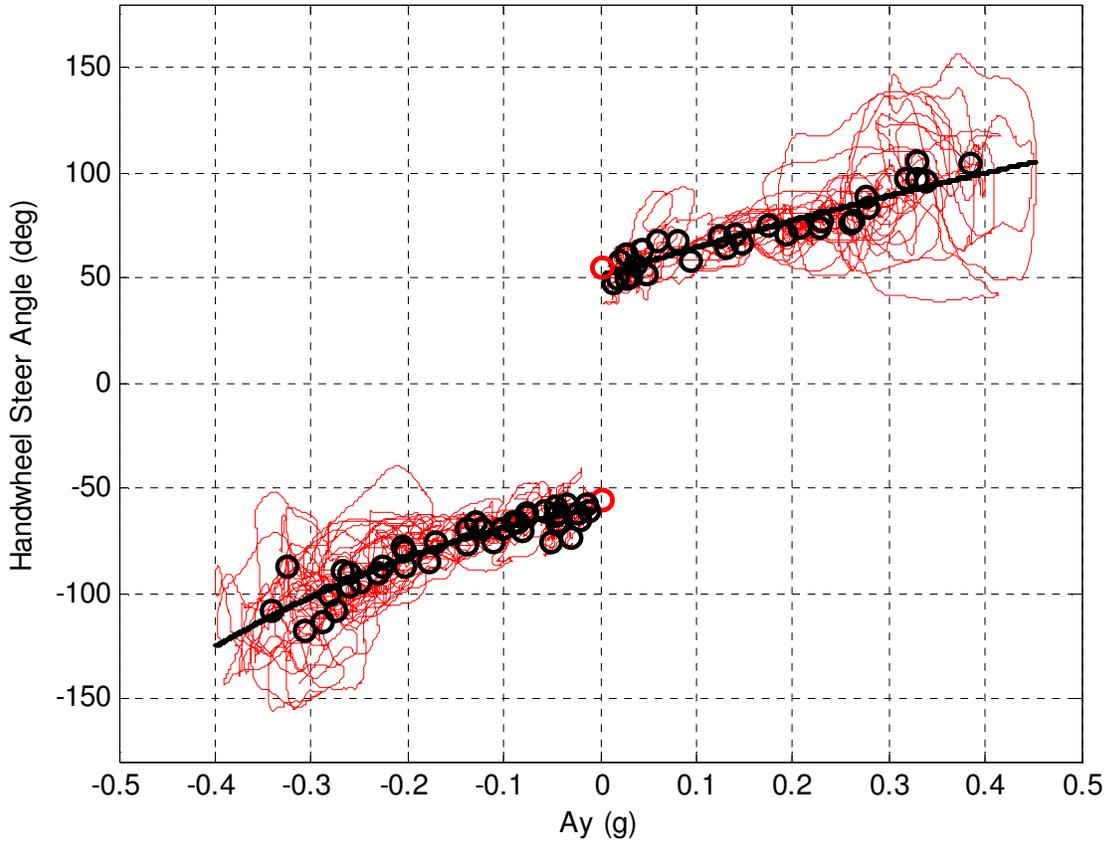
Vehicle G - Tests on Dirt - Set #1

Page 7 of Appendix B shows results from Set #1 tests on dirt and Set #1 tests on asphalt for Vehicle G. The red lines are the underlying data, the black lines are the second-order polynomial curve fits to the data, and the black circles are discrete points from averaging 0.5 second intervals (500 samples) of handwheel angle and lateral acceleration. The discrete points are generally scattered around the curve fit lines; but again, the scatter is greater for the tests on the dirt surface than for the tests on asphalt.

For Vehicle G, pages 1 through 3 of Appendix B contain results for the three sets of circle tests on dirt and pages 4 and 5 contain results for the two sets on asphalt. As was the case for Vehicle F, the data from the tests conducted on dirt are not as smooth or as repeatable as the data from the tests on the asphalt surface. Again, the graphs indicate that the driver's steering inputs were more active (*i.e.*, requiring larger magnitude steering corrections) at all test speeds for the tests conducted on dirt than on asphalt. Lateral acceleration, roll angle, and yaw rate responses were also less smooth for the tests conducted on the dirt surface. As the circle tests on the dirt surface progressed, slight ruts and ridges formed along the wheel paths of travel. These ruts and ridges likely contributed to the less smooth vehicle responses and driver steering inputs.
